The 2005 Mesa County Irrigation Audit Program

Final Report

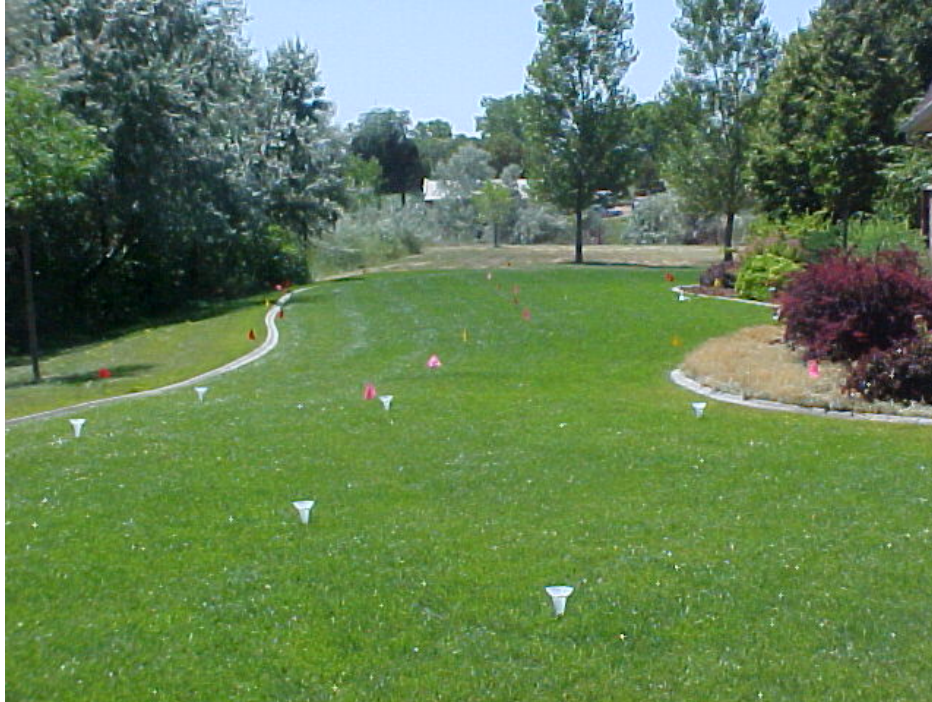
Catch Cans in place for the Advanced Level Audit

The advanced level audit determines the precipitation rates and distribution uniformity of each irrigation zone. Catch cans are used to collect precipitation data from each zone or overlapping zone. When combined with the historical Evapotranspiration (ET) data for this area, the soil type, rooting depth and microclimate, this information provides detailed guidance on how each participant should set their irrigation clocks. This includes the number of days each zone should be watered each month, and the number of cycles and length of time for each cycle. Fifteen advanced audits were conducted and details were provided to each participant on how to accurately set their irrigation clocks each month from April through October.

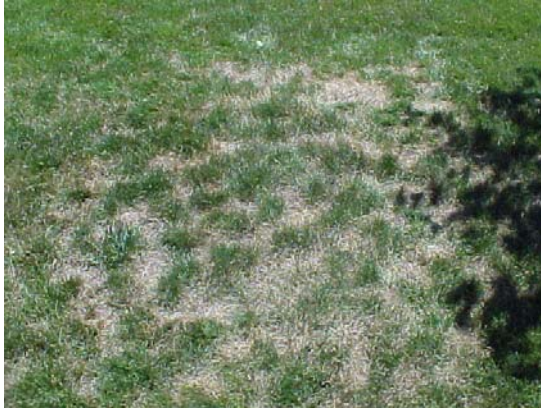
Dry Spots

- Impact heads rotating in full circle and partial circle with the same nozzle size results in more water being applied to some areas with other areas not receiving enough water to keep the lawn green. Several owners increased the amount of time on those zones in order to get more water to the dry areas. This resulted in areas with partial circle heads receiving more water than can be absorbed. By changing the nozzle size on the partial circle a more uniform application with less waste and less plant damage results.

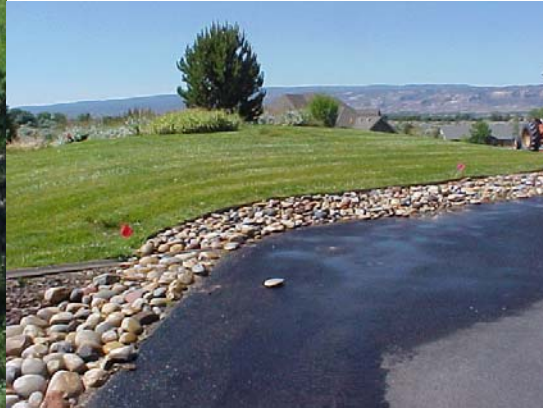
Excess runoff

- Sprinklers out of adjustment were a major cause of wasted water. By making simple adjustments to the spray heads, water could be applied to the turf areas and not the hardscapes.
- Low pressure was a problem for one customer with one zone not having enough pressure to rotate the heads. This caused heads to remain stationary and resulted in water running off the sidewalk into the gutter.
- Most participants were required to water based on the schedule of the subdivision. Watering between 10 p.m. and 6 a.m. helps reduce evaporation and results in fewer turf disease problems. Information on when to water was provided all participants in hopes the subdivision watering schedules could be changed.

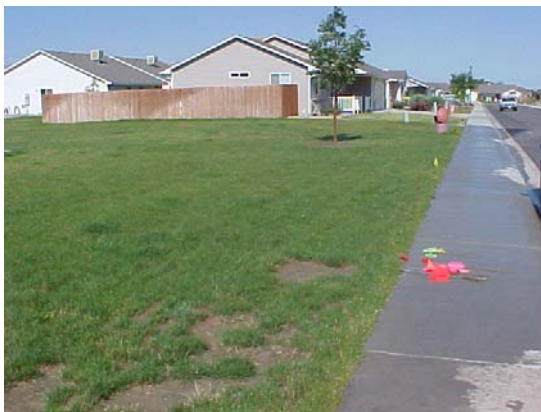
Flooded/swampy areas

- Leaks were discovered during these audits. In one instance, water was running into a window well and basement. Another break in an irrigation line flooded the neighbor's yard and continued into the gutter.

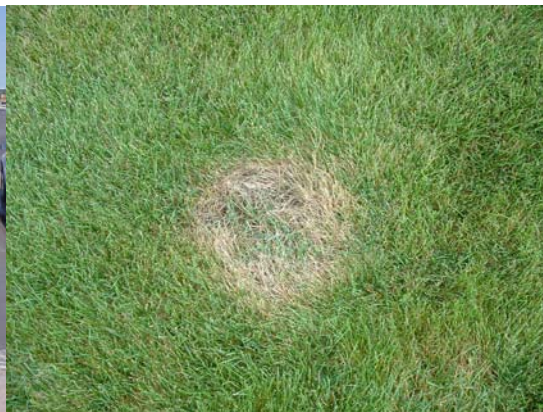
Disease problems
